# GE 7FA A042 Transition Diffuser Duct Repair

## Application Brief

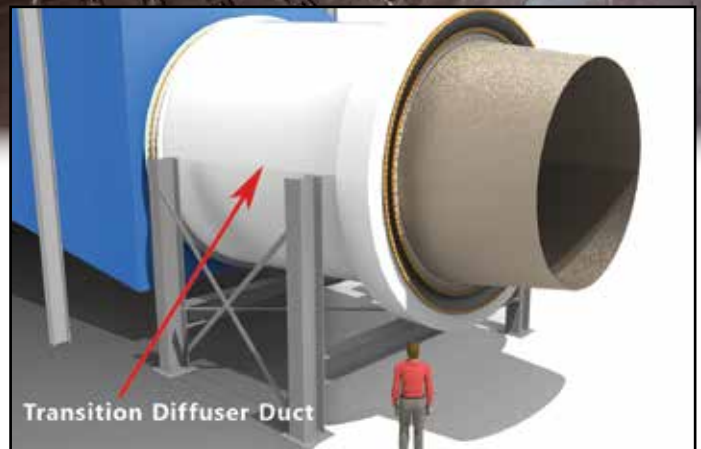
Located between the Flex Seal and the HRSG Inlet, the A042 diffuser duct is comprised of insulation covered by thin gauge stainless steel liner plates that are secured in place by studs welded to scallop bars. There are hundreds of studs welded to the scallop bars that hold the liners in place while allowing them to expand and contract during cycling. The studs and bars are imbedded in dense high-temperature insulation.

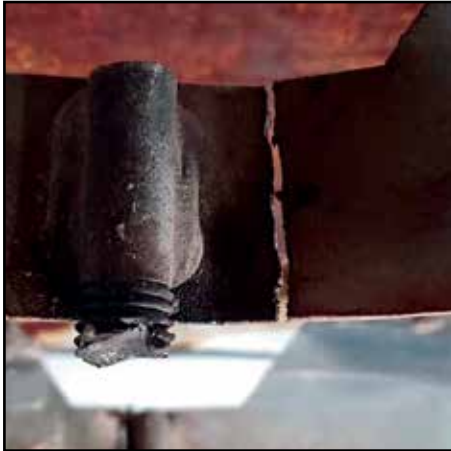
*Typical scallop bar crack*

- Loose or broken studs
- Scallop bars cracked or detached
- Liner plate distortion and fatigue cracks
- Insulation breakdown and voids
- External hot spots and missing/flaking paint

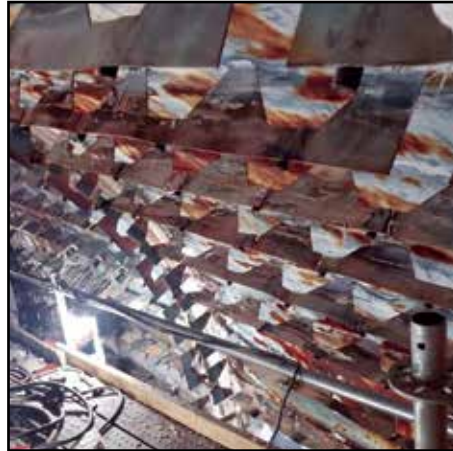
*Scallop bar distortion and cracks*

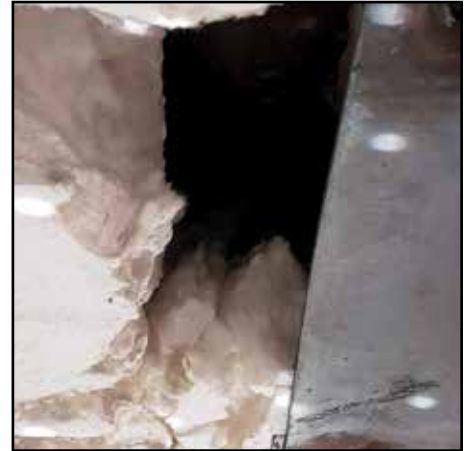
*Insulation void*

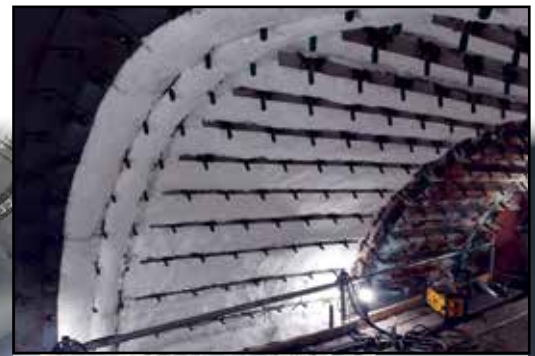
*Typical insulation installation progress*
